## INSPECTION REPORT

1234 Sample Street 011211.

INSPECTION LOCATION:	1234 Sample Street, Anywhere, OR.
CLIENT'S NAME:	Sally and John.
CLIENT'S E-MAIL:	sally@comcast.net.
PHONE #:	123-456-7890.
DATE OF INSPECTION:	January 12, 2011.
TIME OF INSPECTION:	1pm.
INSPECTOR:	Scott Neimann.
CLIENT'S AGENT:	Realtor Agent, Coast Realty.
AGENT'S PHONE:	503-987-6543.

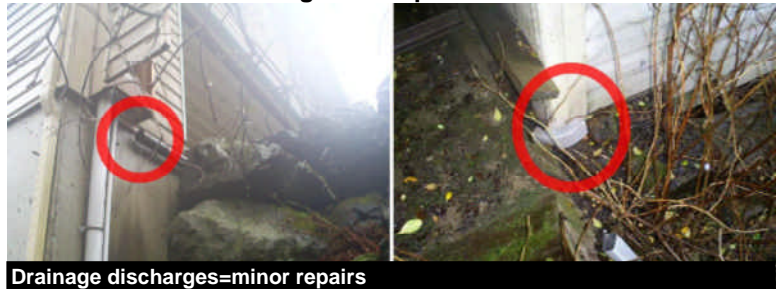
Drainage discharges=minor repairs

Use of Rain Gutters and Downspouts is Good. Some of the downspouts do not discharge into a rain drain. = consider upgrade to help divert roof drainage away from the foundation.

= Extend downspouts, add elbows, etc... to divert roof drainage away from the foundation footings.

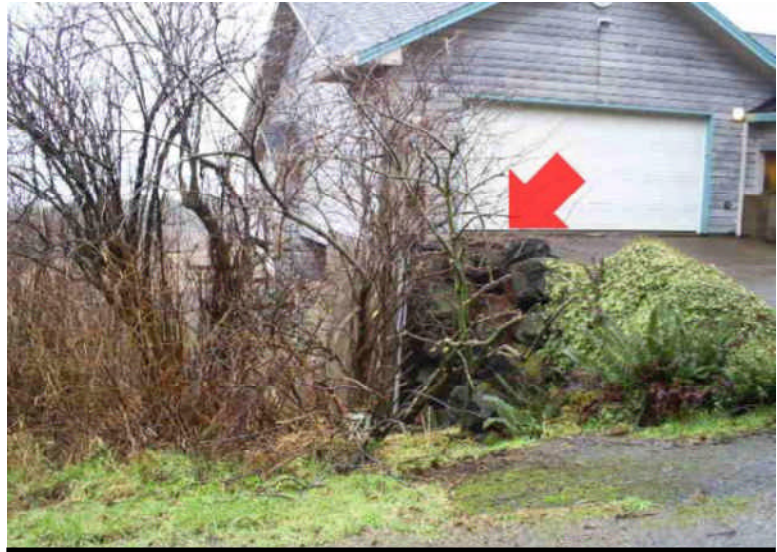
**Left Retaining Wall. No Railing**

The left retaining wall along the driveway is high with no railing along the drive. = Recommend railing for added safety.

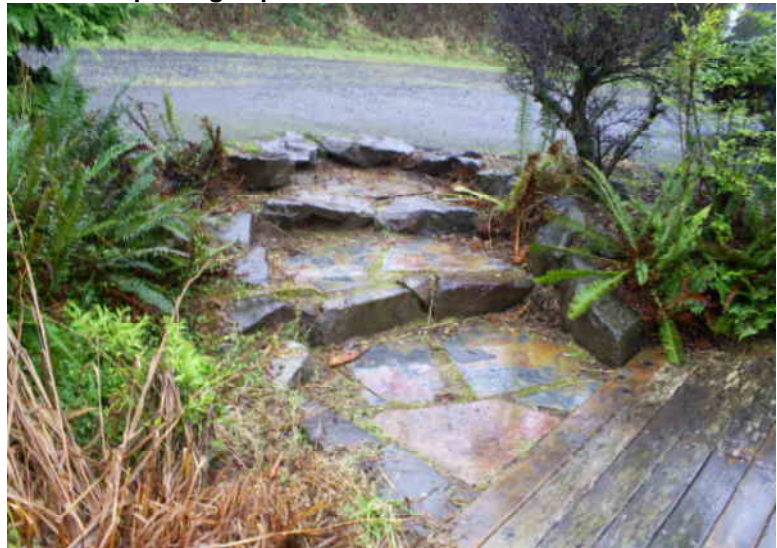
**Walkway step uneven=caution**

The stone walkway/steps to the front entry are uneven and a potential trip hazard = Consider repair/upgrade for added safety.

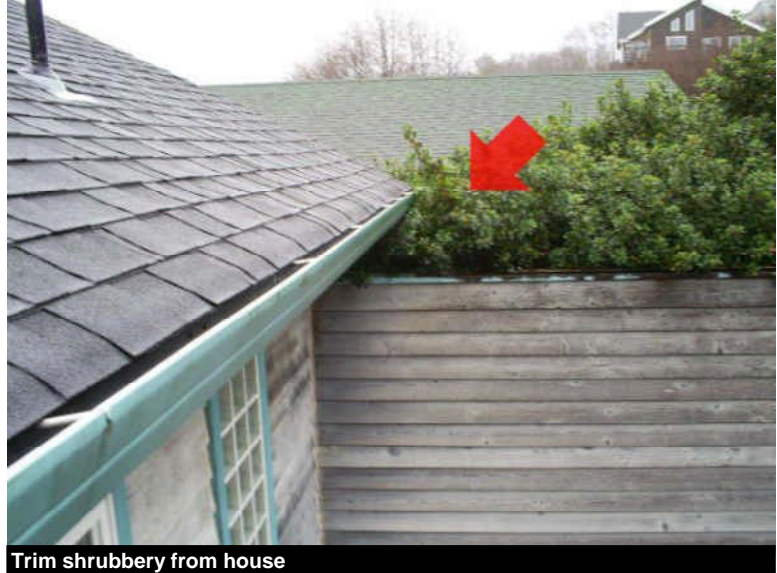
Trim shrubbery from house

General condition is Fair. Trim and maintain shrubbery away from the house. Approximately eighteen inches is desirable.

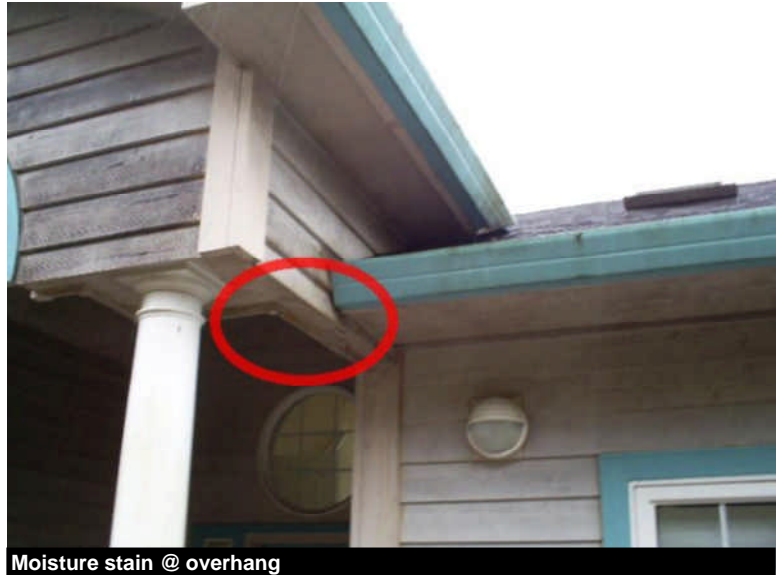
**Moisture stain @ overhang**

1) Some moisture staining was noted at the front entry where the roof flashing is inadequate. Moisture is getting behind the siding and ends up at the eave overhang at the front entry. = Install kickout flashing at roof/wall joint and caulk as needed to help prevent further moisture entry.

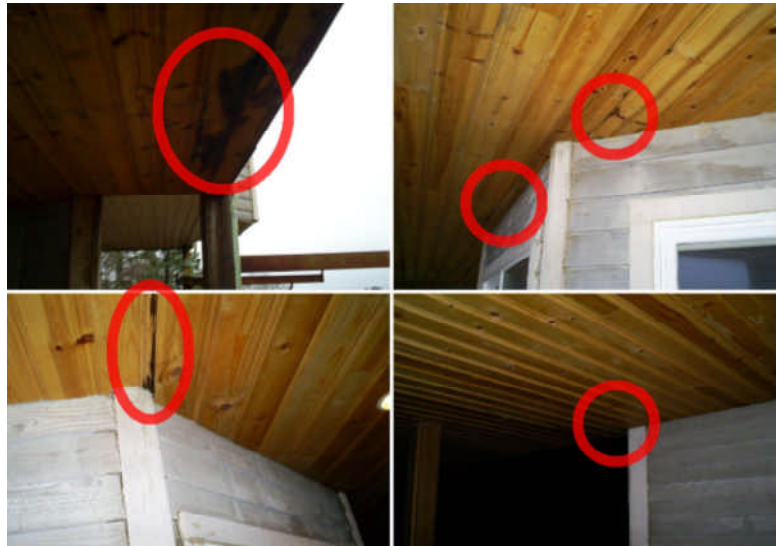
2) The deck overhangs show evidence that the solid surface decks are allowing moisture entry along their edges and at the house/deck joint. Moisture staining is visible at the wood soffits on the underside of the decks.

**Deck soffit moisture stains**

= Further evaluation and repair by a licensed contractor is recommended.

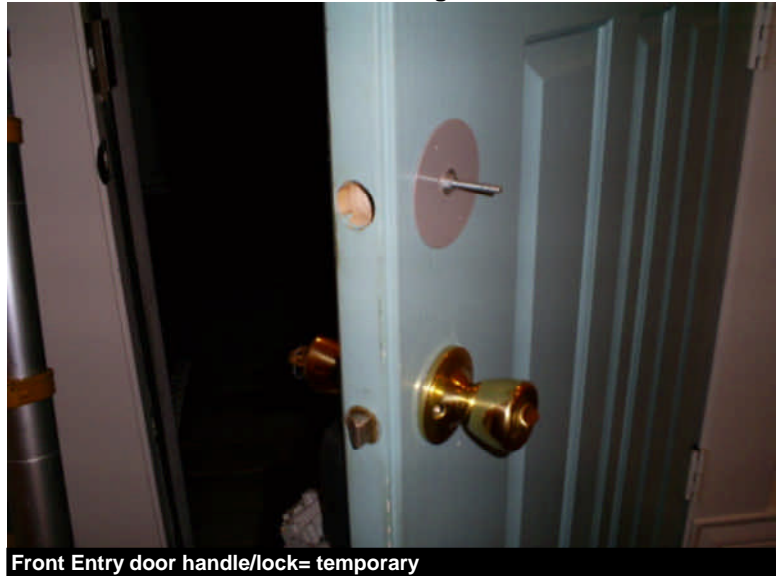
Front Entry door handle/lock= temporary

Acceptable. The original handle and locking mechanisms have been removed and a temporary knob/lock has been installed. The original was on the premises = Re-install front entry door handle/lock as needed. Consider re-keying the locks for security.

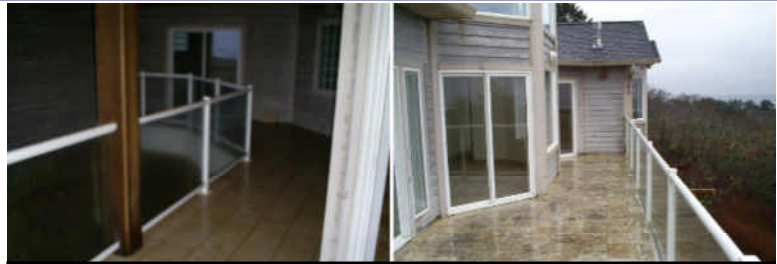
**Solid surface decks installed**

Because of moisture staining visible at the underside soffits and on interior wall/ceiling/window/door surfaces, It is recommended that a licensed contractor further evaluate the solid surface decks for leakage. Repair as needed.

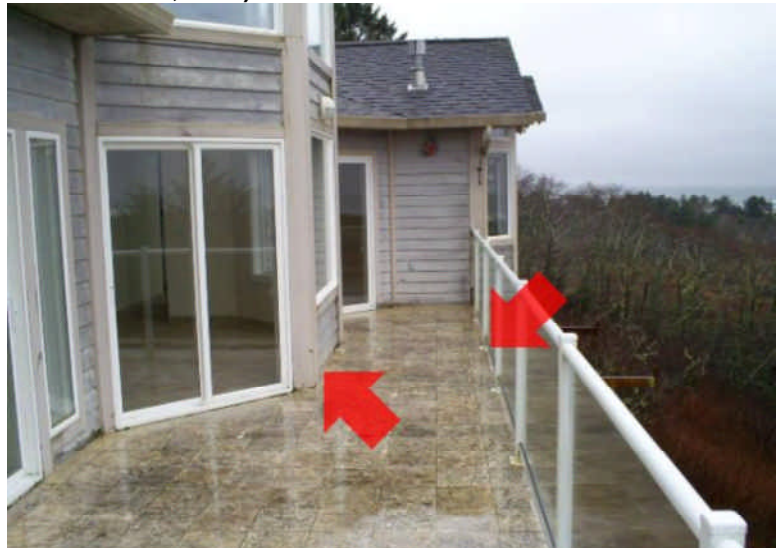
**House joint, edge flashings inadequate**

Only caulking is visible at the deck house joint. I could not determine if flashing is installed at this critical joint. Moisture staining at the soffits below and interior moisture indicate the flashing is inadequate and moisture entry is occurring. = Further evaluation/repair by a licensed contractor is recommended.

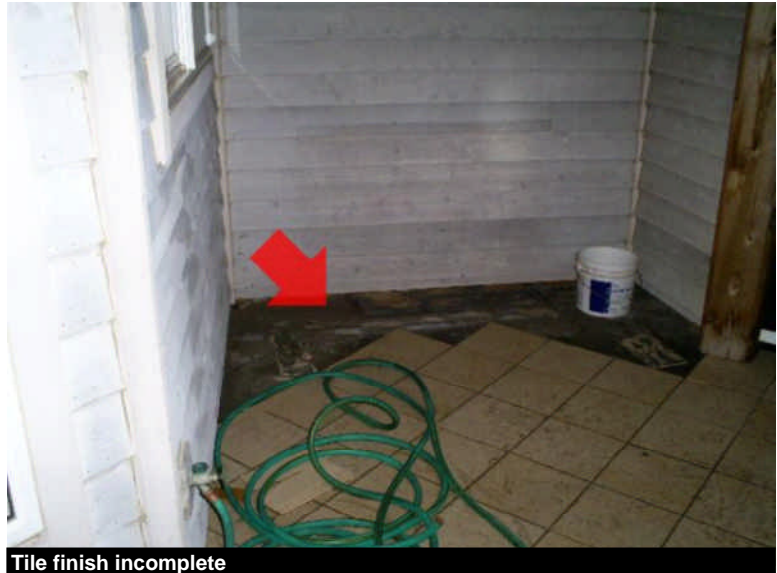
**Tile finish incomplete**

A portion of the tile decking installation is incomplete (or has been removed). = Recommend installation by licensed contractor.

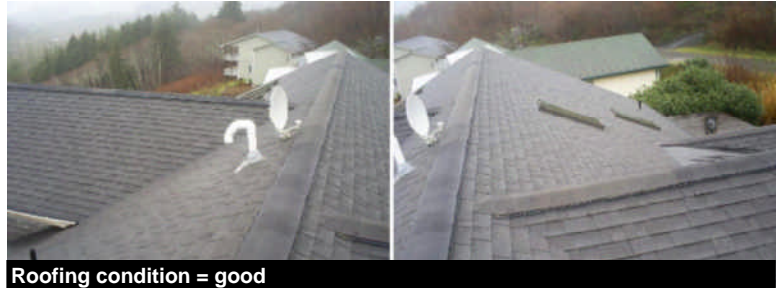
**Roofing condition = good**

Good.

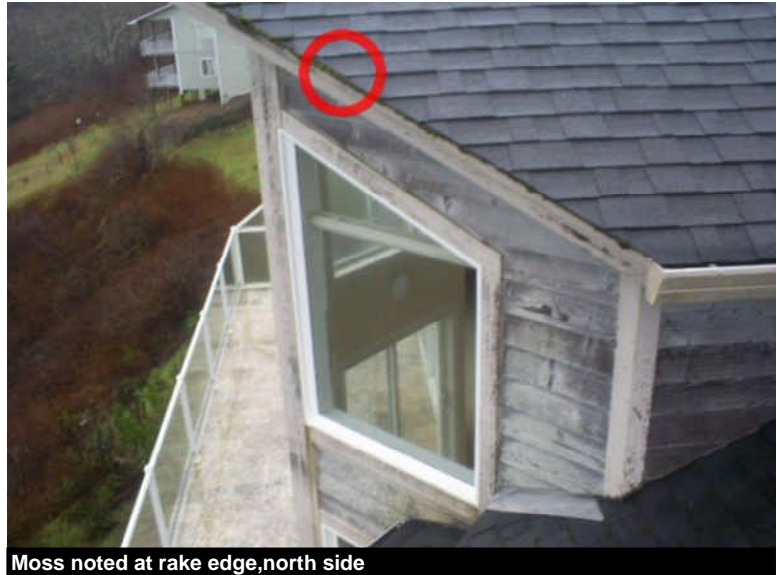
Moss noted at rake edge,north side

Some of the shingles showed the following conditions: typical moss growth noted on north or shaded areas. Regular roof maintenance can extend the life of this roofing material.

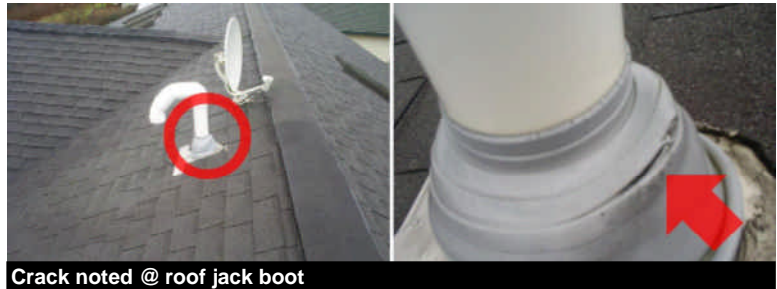
Crack noted @ roof jack boot

The roof jack boot on the furnace vent penetration is visibly cracked = repair/replace as needed to help prevent moisture entry.

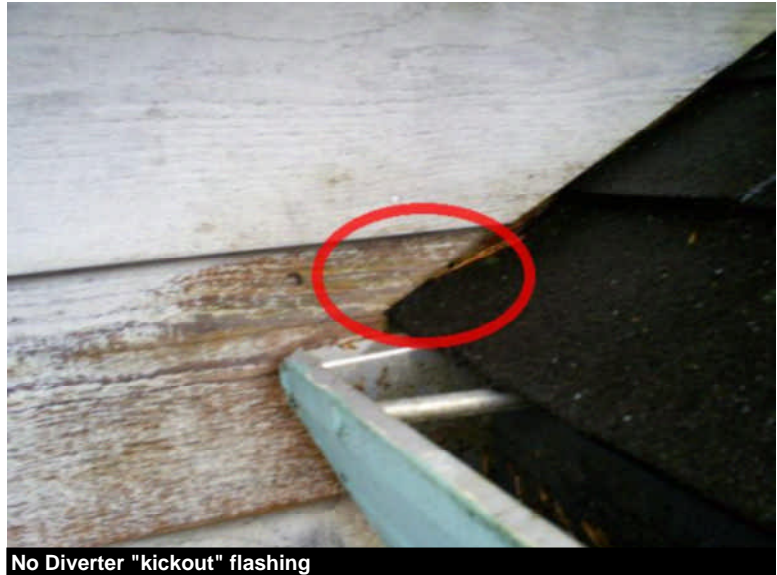
**No Diverter "kickout" flashing**

Diverter kick-out flashings are not installed. These flashings are used above the termination of a lower roof and a vertical wall. The flashing helps to divert water away from the wall to prevent moisture damage within the wall = Recommend the installation of diverter kick-out flashings to help prevent water damage to the wall systems.

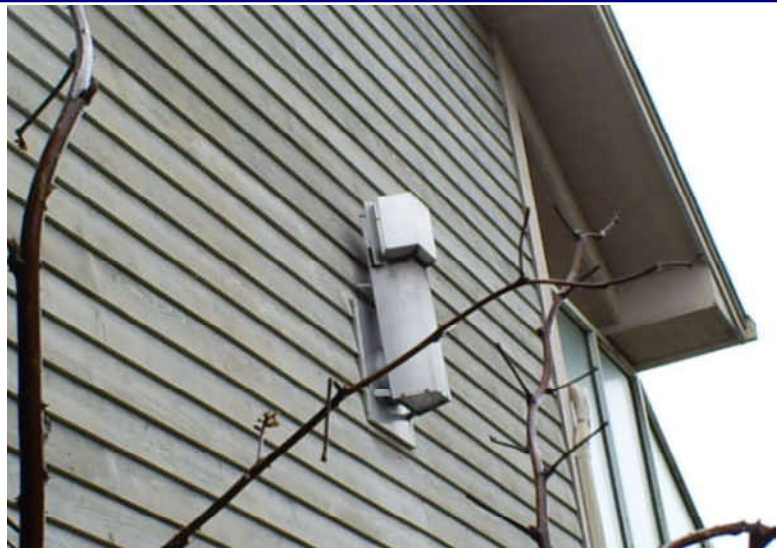
**Direct vent flue for Gas Fireplace**

Acceptable.

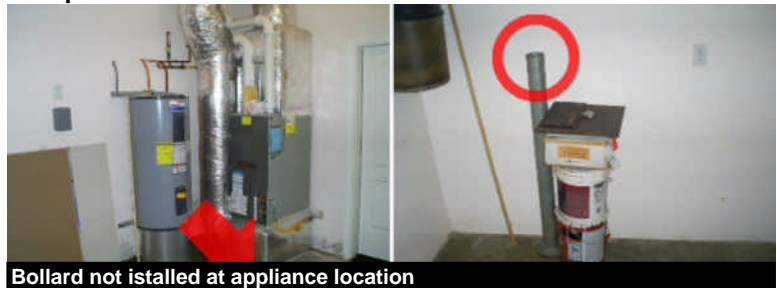
Bollard not installed at appliance location

The steel bollard is not installed to protect the furnace (gas line) and the water heater from accidental car impact. = Installation recommended for safety.

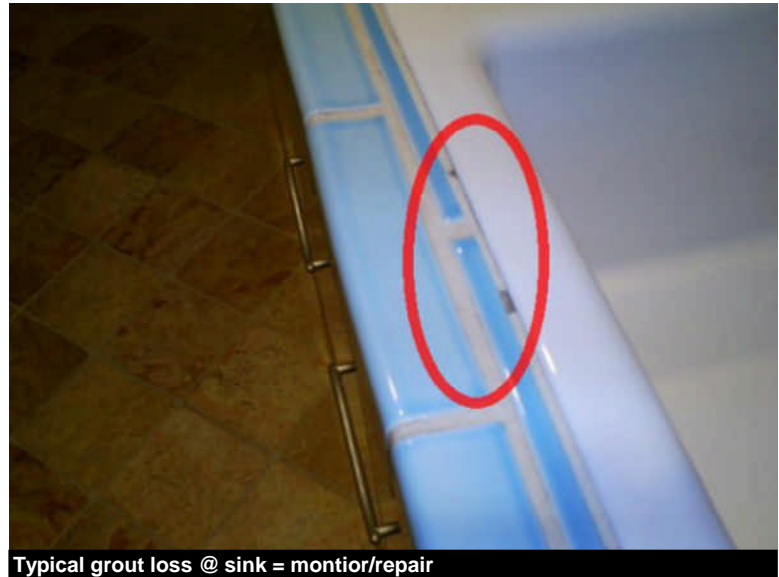
Typical grout loss @ sink = monitor/repair

Good. Tile. Some typical grout cracking/missing noted at sink location = monitor and repair as needed.

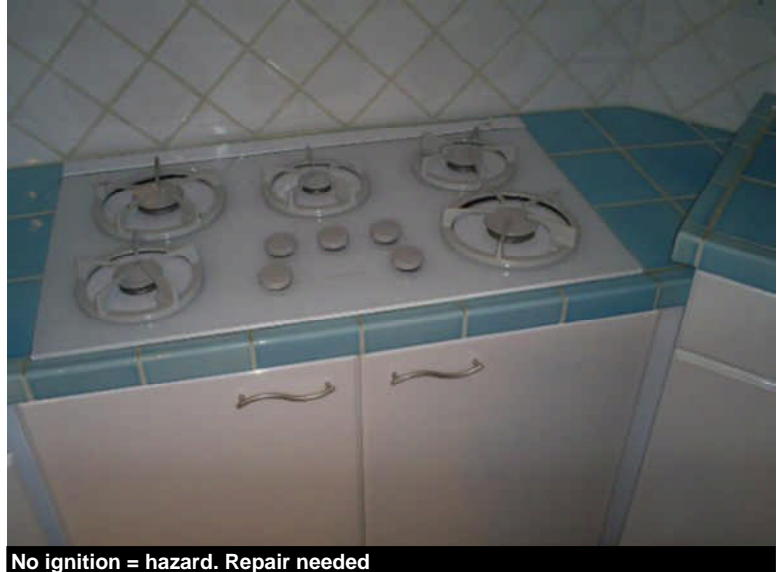
No ignition = hazard. Repair needed

The propane stove ignition system did not respond to knob controls. Propane was present, but no ignition occurred = potential hazard. We recommend further evaluation by a licensed gas appliance technician. Repair as needed.

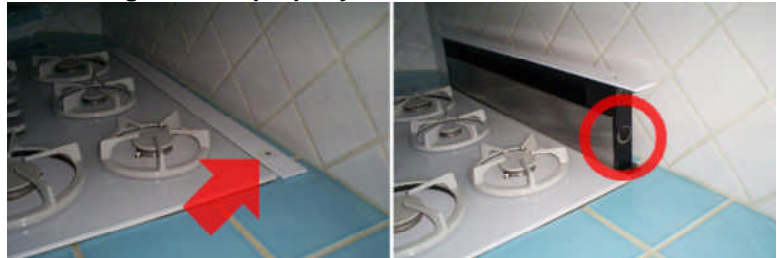
Exhaust Fan control location

**Type: Downdraft. - Functioning: Yes. The fan was turned on, tested, and then turned back off.**

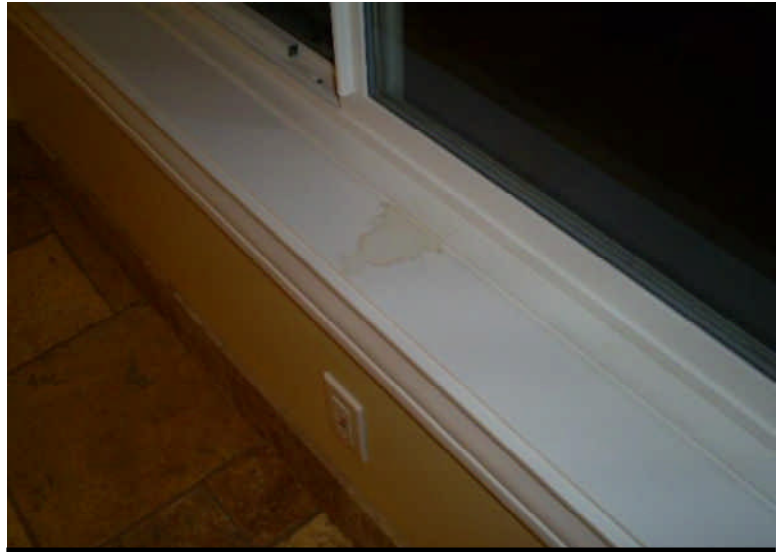
**Moisture stain @ window sill**

Moisture stains were noted on the window sill. No current moisture was observed, but the exterior soffit at this location appears to be wet and some leakage from the above deck joint appears to be present = further evaluate and repair as needed.

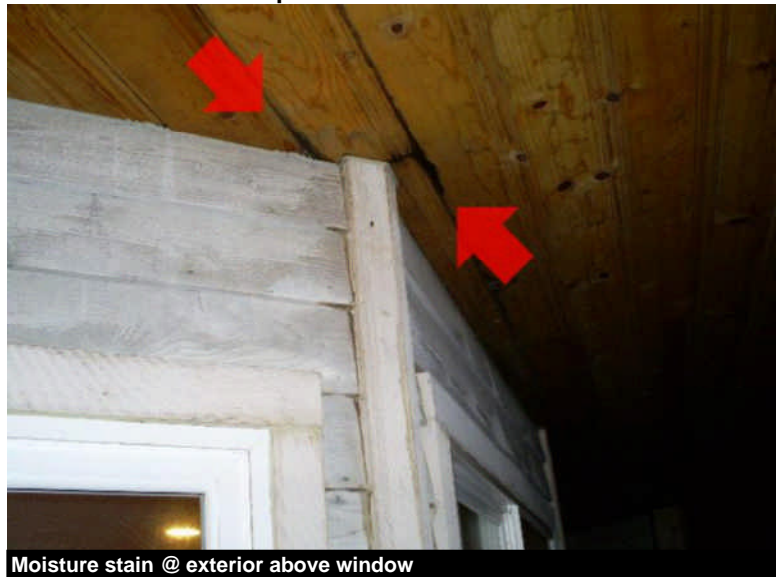
**Moisture stain @ exterior above window**

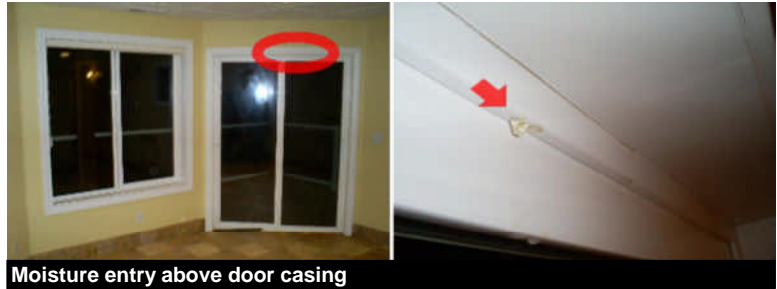
Moisture entry above door casing

Moisture was dripping from above the exterior sliding door casing. This moisture is most likely coming from the solid surface deck joint above. = Further evaluation and repair is recommended.

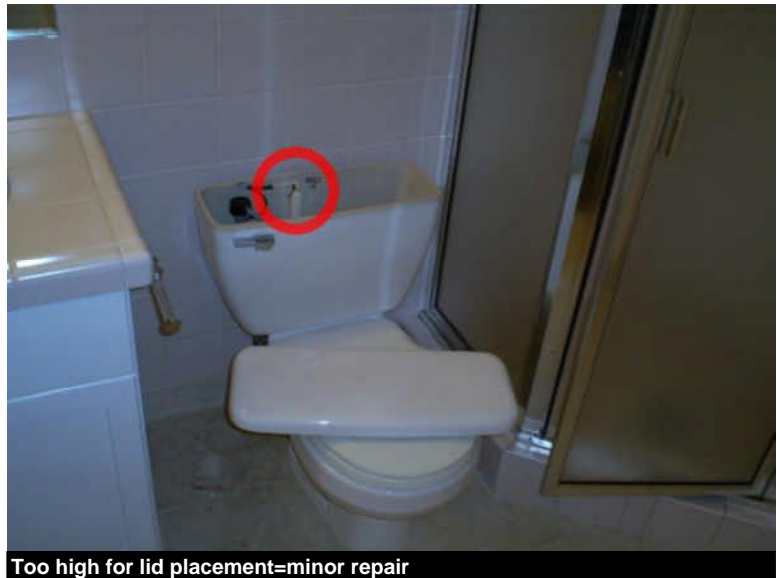
Too high for lid placement=minor repair

PLUMBING LEAKS:	The lid does not fit properly on the tank because the flapper riser is too high = minor repair needed for lid to sit properly on the tank.
BATH FIXTURE:	None apparent at this time.
SHOWER PAN/TUB:	Shower only.
TUB/SHOWER SURROUND:	Good.
SHOWER ENCLOSURE:	Good. Regular caulking of the seams and joints is required to keep water penetration to a minimum.
TUB/SHOWER PLUMBING:	Door - General condition is Good. Good.

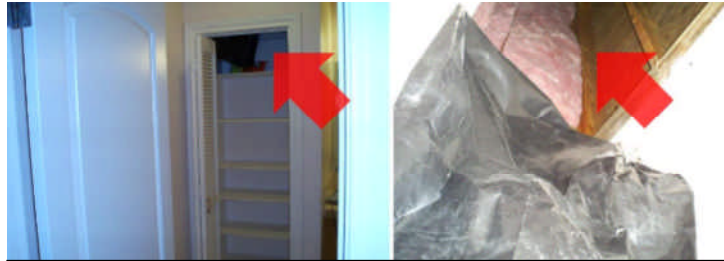
**Attic Access. No Hatch cover.**

The ceiling has been opened within the closet to access an attic space above. The opening allows heat to escape the living space of the home = repair ceiling for added heat efficiency.

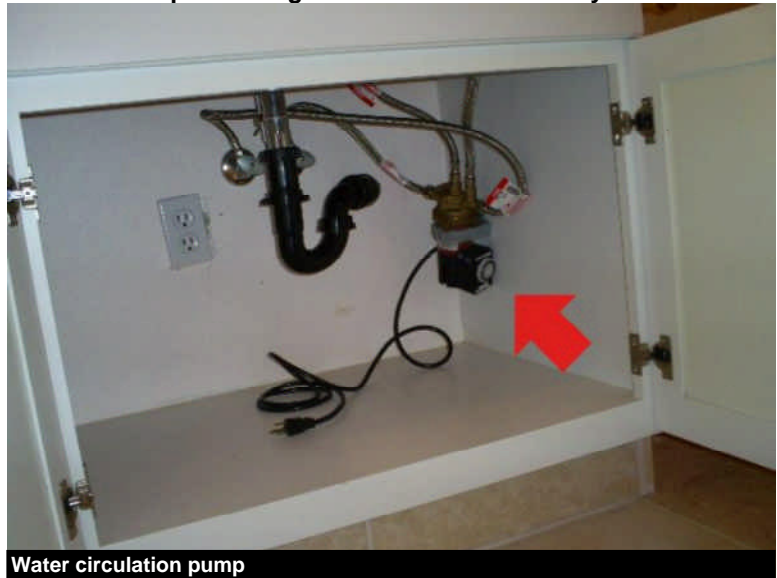
**Water circulation pump**

A water circulation pump is installed under the sink. A timer mechanism appears to be present. These are often installed at locations that are a distance from the water heater to help supply hot water quicker to the location. The unit was unplugged = did not test.

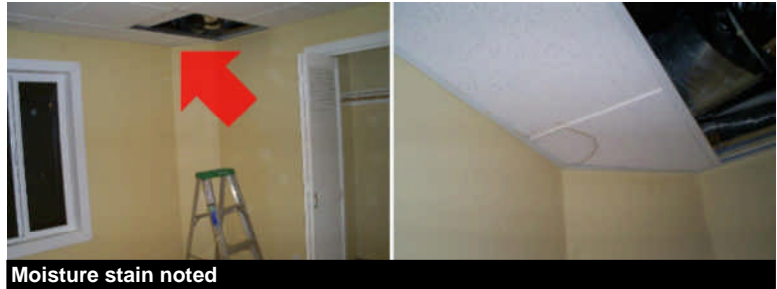
Moisture stain noted

A moisture stain on the acoustic ceiling tile was noted. I opened an adjacent tile and viewed the drop ceiling from above. No visible evidence of current leaking was observed. The source of the stain is unknown, but may be the result of leakage at the furnace condensation drain line that is directly above the observed stain. = Monitor and repair as needed.

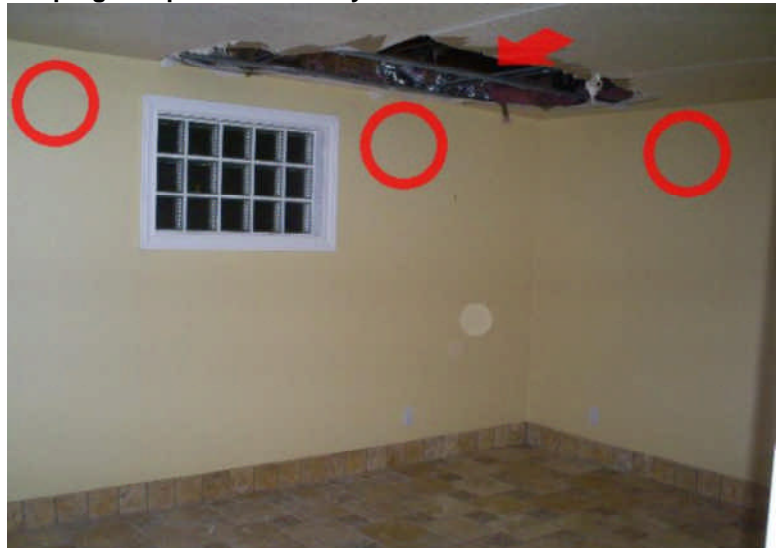
Paint sag=moisture. Ceiling Damaged

Paint sagging indicates past excess moisture conditions. On the day of inspection I did not view any moisture that would explain the condition. Plumbing is present in the ceiling above the area and may explain the source of moisture, though I could not positively determine, as there was no leakage on the day of inspection. = Monitor and repair as needed.

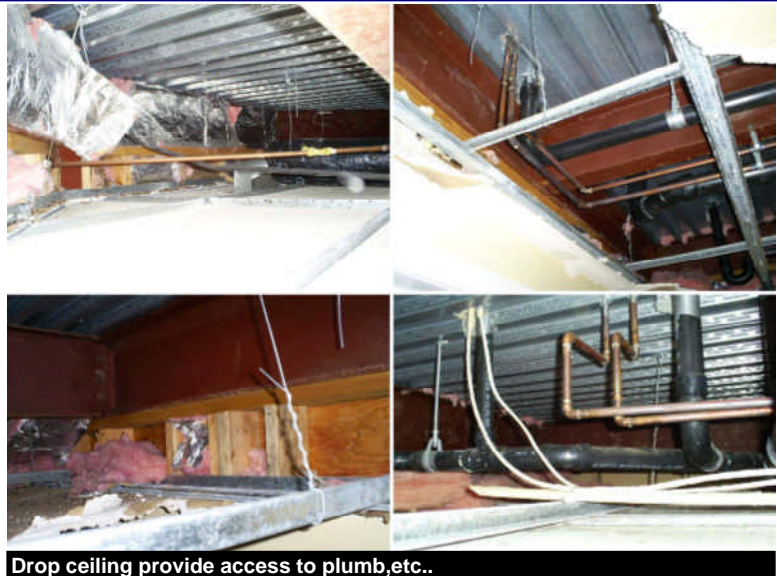
Drop ceiling provide access to plumb,etc..

Areas of repair are needed where ceilings have been opened. See individual room notes for details.

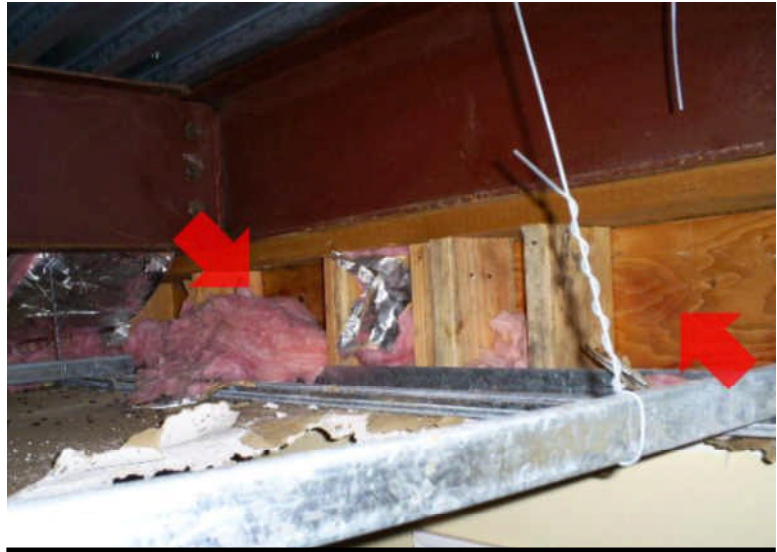
**Exterior wall insulation removed/fallen**

Unable to determine if the walls are insulated.

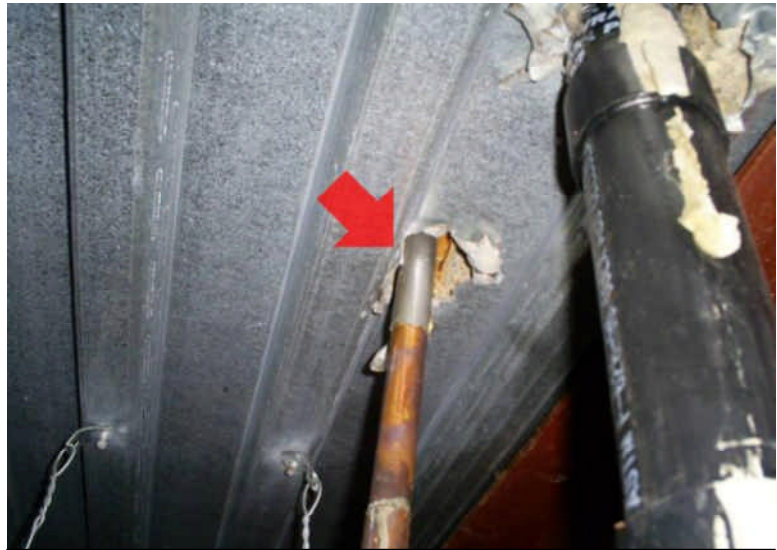
**Copper water pipe penetration. Edges.**

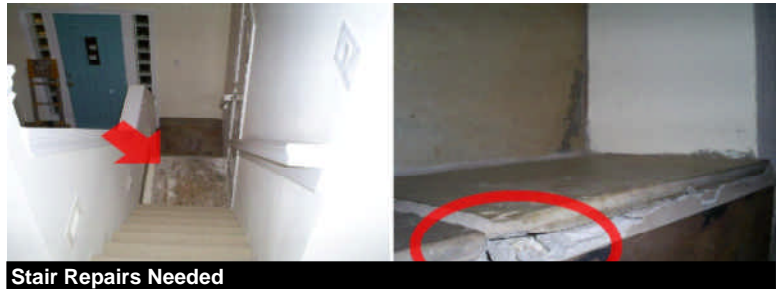
Stair Repairs Needed

LIGHTING:	The tile steps need repair. Loose/cracked grout noted. In addition, the tile has been removed at the garage entry landing. The missing tile creates a potential trip hazard. = Further evaluation/repair is recommended for safety. Two of the wall lights did not respond to switch = check bulbs, then fixture. Repair as needed.
HEAD CLEARANCE:	Good.
RAILINGS STURDY:	General condition is Good.

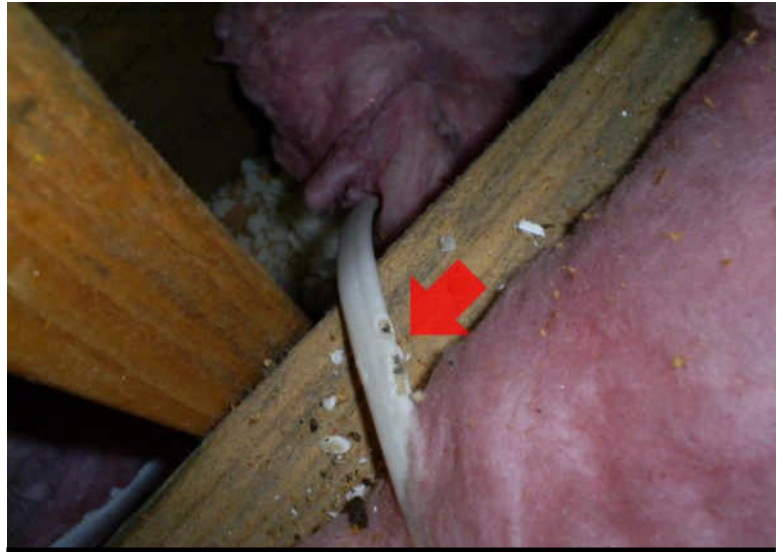
**Insulation chewed = rodent activity**

Rodent damaged insulation was noted at one location. = Rodent control should be maintained to help prevent further damage to electrical wiring.

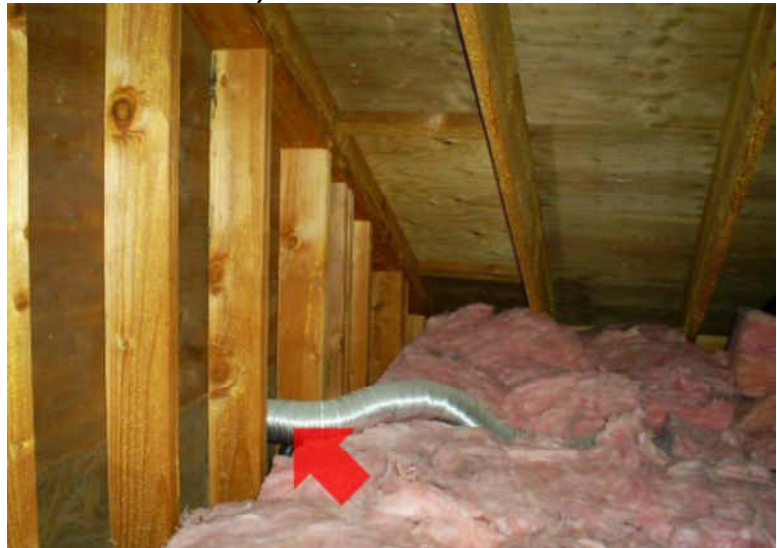
**Bath exhausts to exterior=good**

The bathroom exhaust fans appear to be ducted to the exterior = good.

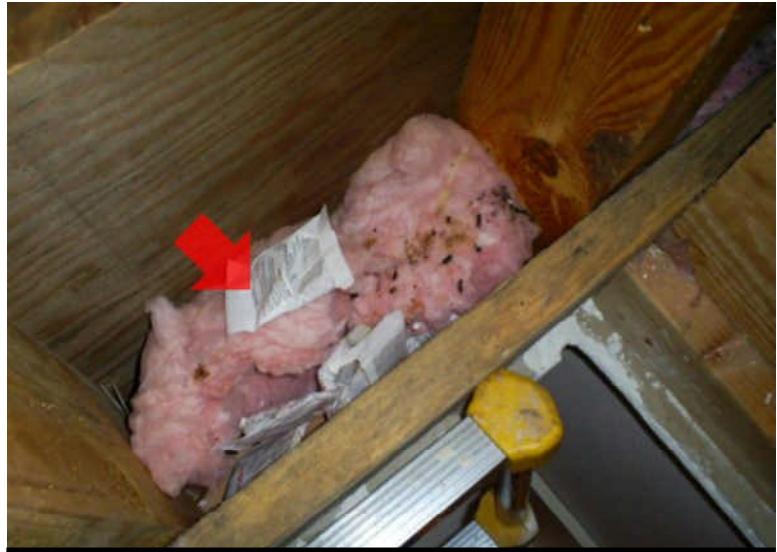
**Rodent bait packages noted**

I observed rodent droppings and bait packages in the attic.=  
Continue rodent control measures. Consider professional rodent control as needed.

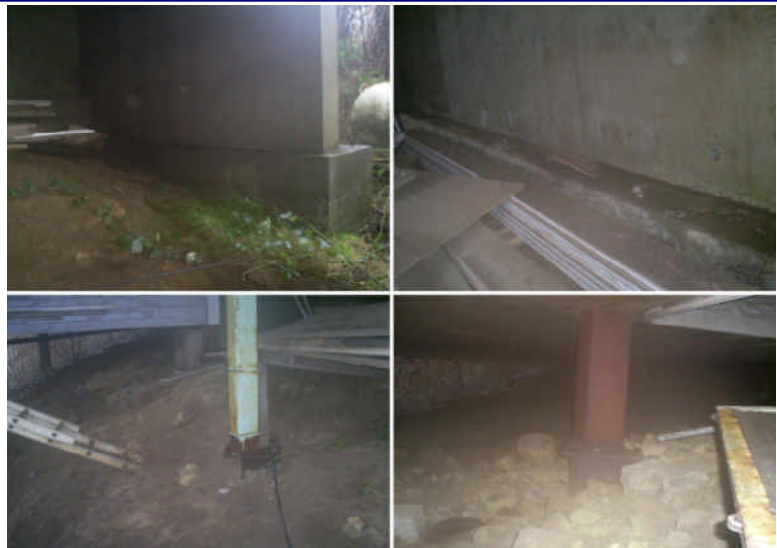
**Concrete Foundation& Steel Posts**

Good. The concrete foundation supports the up hill side of the home.  
The lower side of the home is supported with steel posts.

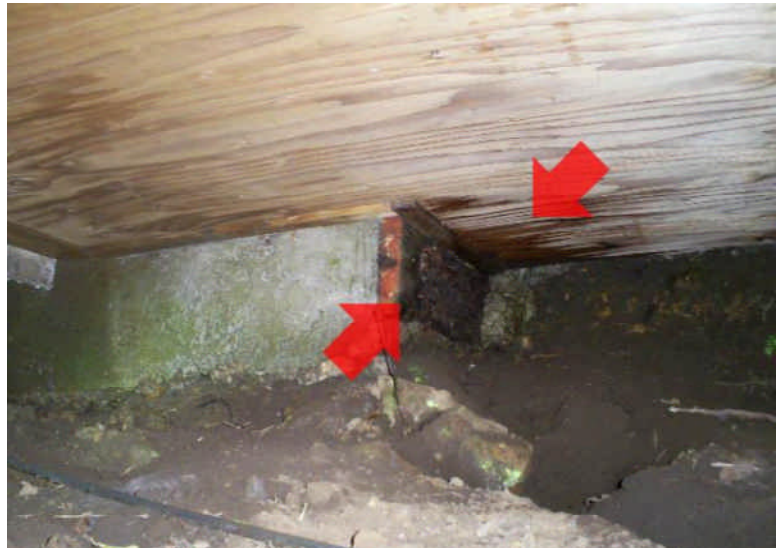
**Wet form board, belly pan. SE corner**

The wood belly pan is moisture stained at the SE corner of the crawlspace. The moisture appears to be the result of wood-to-earth contact or contact with the concrete footing that is seeping moisture at the joint. Wet wood can attract wood destroying insects and, over time, will allow rot to damage the wood. The wood belly pan covers under floor components above and no visual evaluation can be made without removing the belly pan. = We recommend further evaluation by a licensed contractor. Repair as needed.

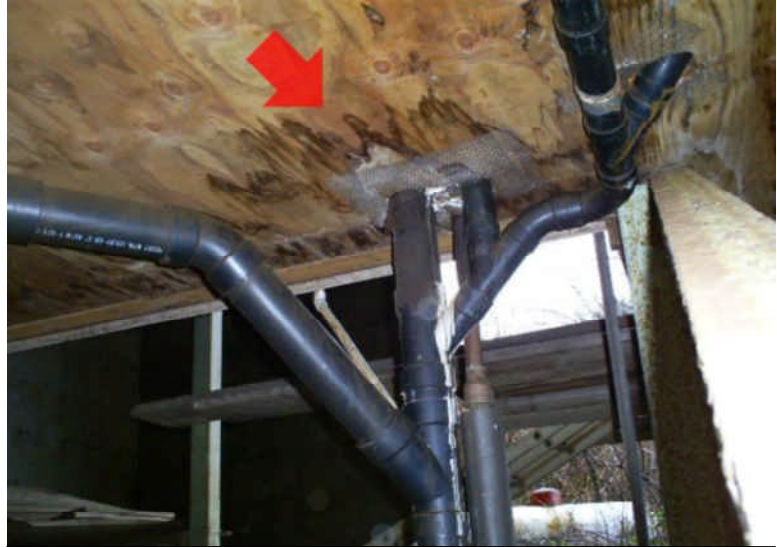
Stain@bellypan = past leaks. Monitor

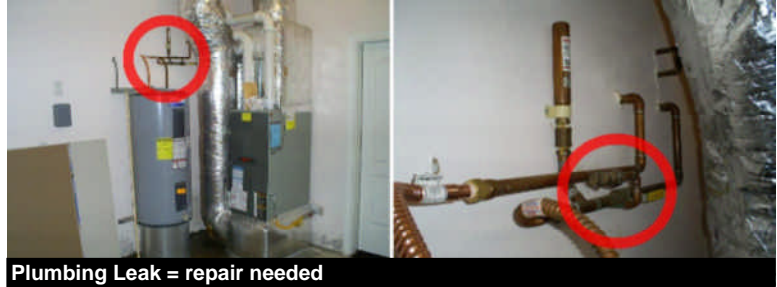
Plumbing Leak = repair needed

There is a plumbing leak in the copper supply plumbing above/near the water heater location = Further evaluation and repair is recommended.

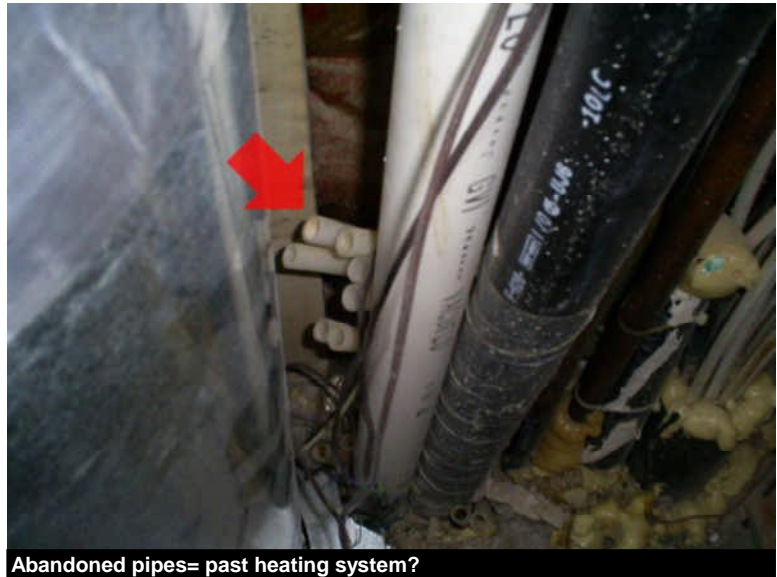
Abandoned pipes= past heating system?

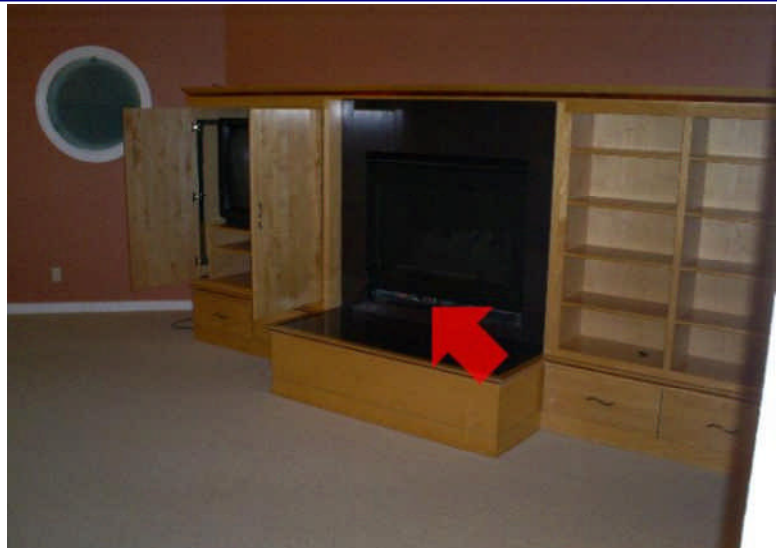
Pilot did not light = evaluate

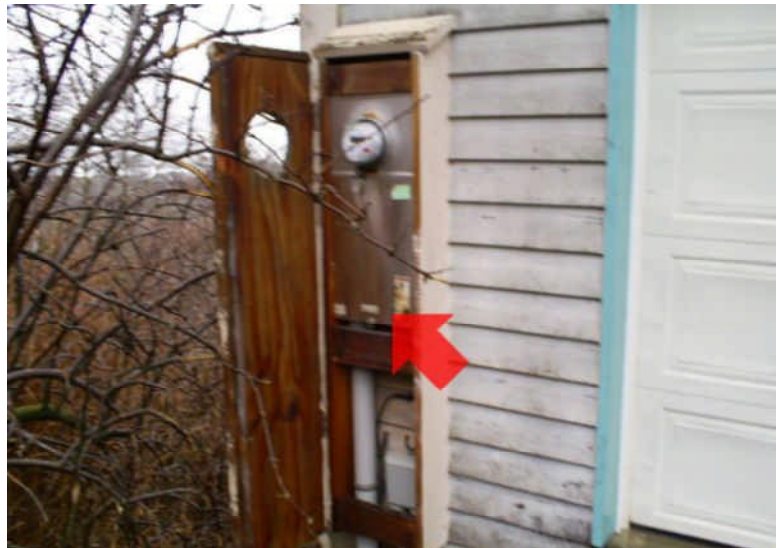
Panel latch rusted=no access

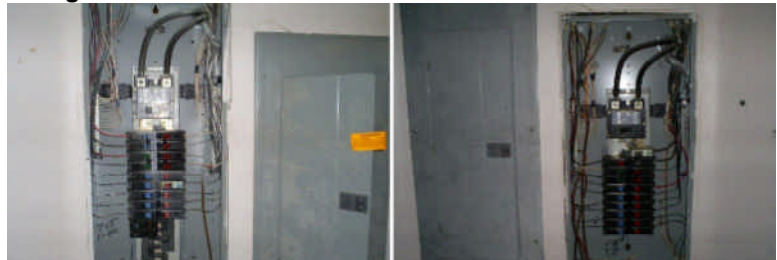
Both Panels wired as "Mains"
